**MARINE INVESTIGATION REPORT
M01M0017**

CONTAINER FIRE

**CONTAINER VESSEL *KITANO*
OFF CHEBUCTO HEAD, NOVA SCOTIA
22 MARCH 2001**

Report Number M01M0017

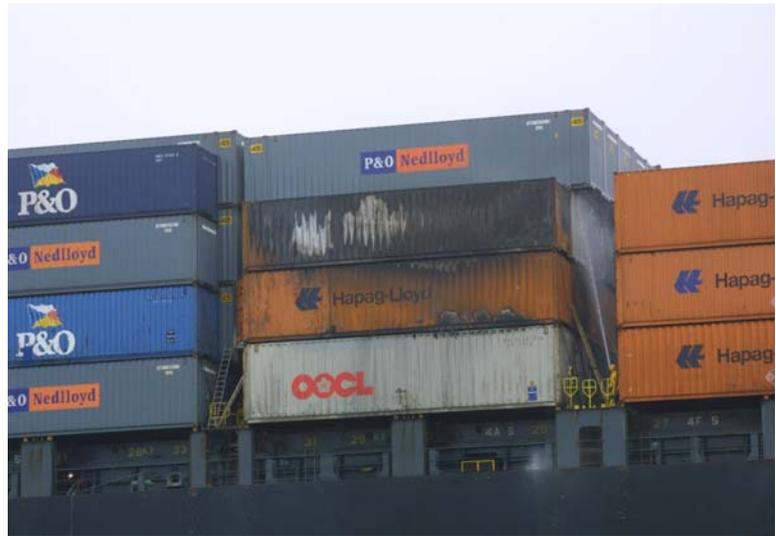
Photo 3. Fire Damaged Containers

Shortly after the vessel was secured alongside, 16 containers including the 15 directly involved in or in close proximity to the fire were removed from the vessel for inspection and assessment. Only one container (300986) loaded with hard cover books had a deep seated fire which required additional attention by the HRM Fire Service. Of the 15 containers removed from the area of the fire, all but one suffered varying degrees of fire, smoke and water damage. The sixteenth container removed had been stored in a cargo hold and contained an identical cargo of the activated carbon pellets as container 301184. An inspection of this container did not reveal a problem with its cargo.

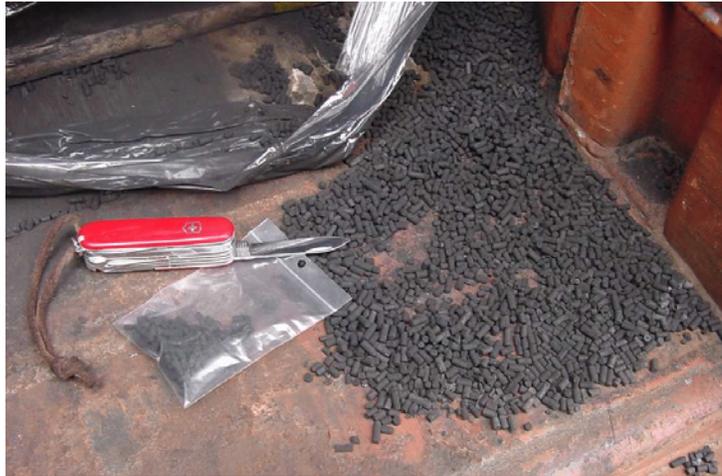
Photo 4. GC IPH Activated Carbon Pellets

The container in which the fire started contained 14 - 115 kg drums and 288 - 44 kg open mesh bags of activated carbon pellets impregnated with potassium hydroxide (caustic potash). The bags of carbon pellets were bundled and plastic wrapped onto 14 wooden pallets. The activated carbon pellets are commonly used for the desulphurisation of gases and the removal of acidic contaminants such as hydrogen sulfide, hydrogen chloride and mercaptans.

1. The results of the chemical analysis were consistent with the information supplied in the manufacturer's material safety data sheet (MSDS).
2. The results of the UN N.1 test for readily combustible solids were not consistent with a Class 4.1 dangerous goods classification.
3. The results of the UN N.4 test for self-heating substances were consistent with a classification of Class 4.2 (substances liable to spontaneous combustion), Packing Group III, when transported in packages with a volume of more than 3m³.
4. The result of the Corrositex® test was not consistent with a Class 8 dangerous goods classification.
5. The temperature rises witnessed in the ad hoc heat rise test were not high enough to produce ignition in themselves. However, given that the GC IPH was self-heating, any increase in heat may have contributed to the likelihood of a fire.

At the outset of the occurrence, the container containing the GC IPH activated carbon pellets was identified as the only unit indicating signs of smoke and extreme heat. In addition glowing carbon pellets were observed falling from the wooden bottom of the container onto another container directly below. A preliminary boundary survey of all the adjacent containers revealed no abnormalities. The container with the activated carbon pellets was the source of the fire.
